Manhole Inspection Summary

Manhole # S55I__008MH

Location Address: **3600 fleet**

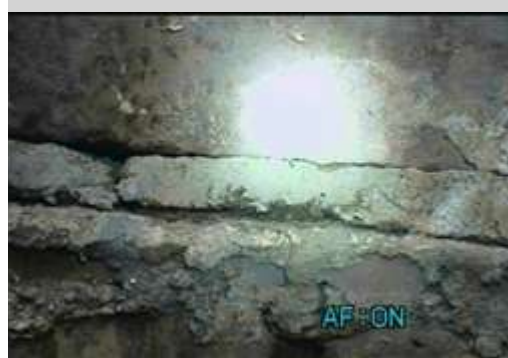
Defect 1

Condition: ☐ Sound ☒ **Cracked** ☐ Root Intrusion ☐ Loose Brick ☐ Deteriorated

frame adj

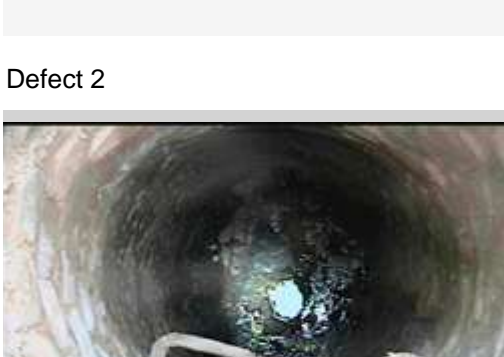
Channel Debris

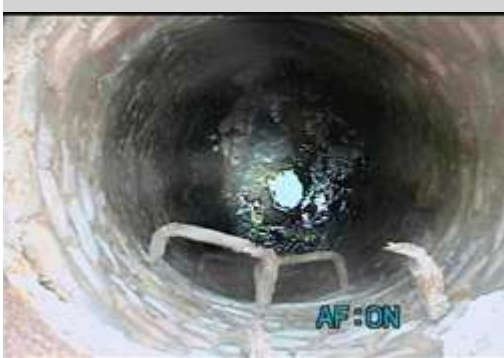
Defect 2

Count: **5** Missing: **1** ☒ **Corroded**

steps

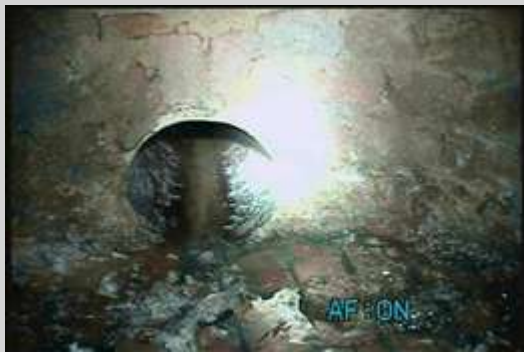
12 O'Clock Outflow

8 in. Circular Gravity Sewer
Pipe Out @ 12 O'Clock

Invert Depth: 10.00 (ft.) Flow Characteristics: Slow

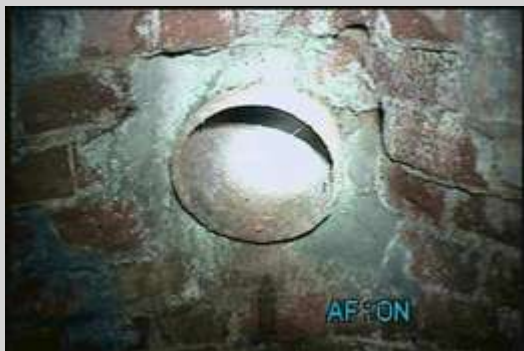
3 O'Clock Inflow

8 in. Circular Gravity Sewer
Pipe In @ 3 O'Clock

Drop In @ 3 O'Clock

Drop: Outside Direct
